The Ultraviolet Detection of Corona Discharge in Power Transmission Lines

Lan Chen¹, Lin Lin², Mimi Tian², Xingming Bian¹, Liming Wang¹, Zhicheng Guan¹

ABSTRACT

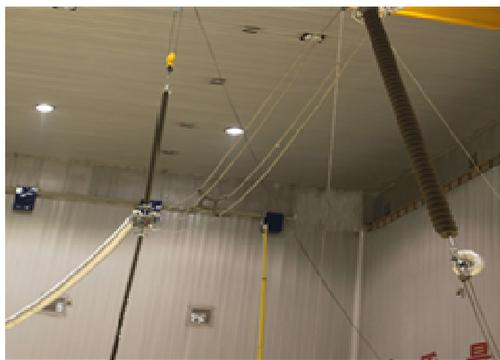
Figure 1. Picture of test model.

The experiment was carried out in a shielding hall with a size of 66 m × 30 m × 18 m, and the test model was 4×LGJ300/40, bundle space was 45 cm, height was 6.8 m, the model picture was showed in **Figure 1**. And the temperature was 8.4°C~10.8°C, relative humidity was 35%~43%.

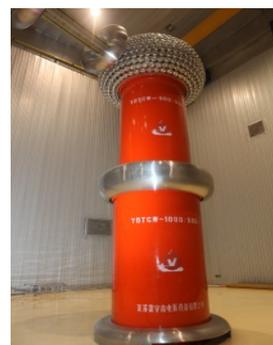
Figure 3. 1000kV transformer.

The UV imager with type of DayCor SuperB was showed in **Figure 2**. And the 50 Hz source with maximum of 1000 kV and 1000 kVA was showed in **Figure 3**.

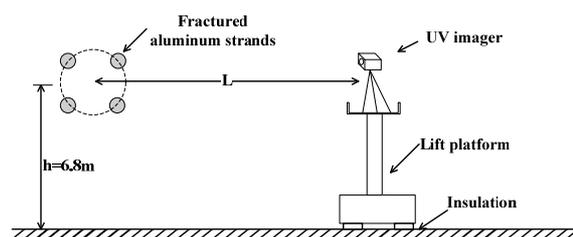
Figure 4. Measurement system schematic diagram.

And the measurement system schematic diagram was showed in **Figure 4**.

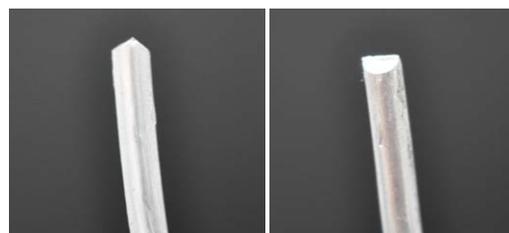
Figure 5. The top of the fractured aluminum strands.

The fractured aluminum strands (see **Figure 5**), was set at one of the LGJ300/40 conductor, with different length (see **Figure 6**).

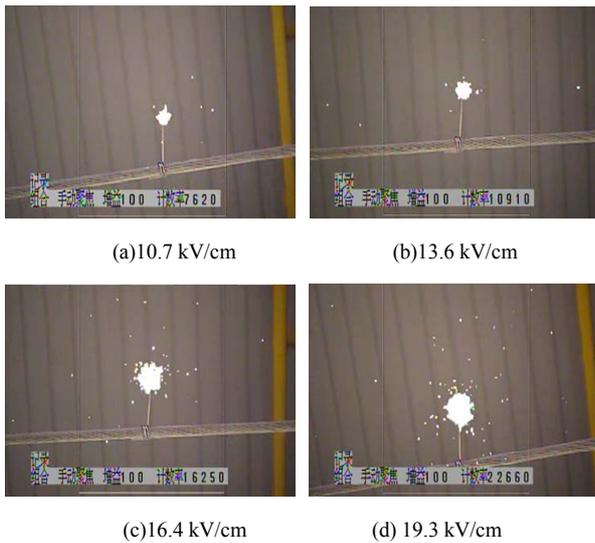
We noticed in Figure 7 that the photon counting rate would increase with the rise of the applied voltage, such as applied voltage was 150 kV (with conductor surface electric field is 10.7 kV/cm) while the photon counting was 7620, with the voltage increased to 270 kV (with field 19.3 kV/cm) the photon counting rise at 22660.

Figure 7. Corona discharge at the top of fractured strand with different voltage applied (length of strand is 10cm, detection distance is 9 m, UV gain is 100).

With the different influence factor applied on the strands, the corona phenomenon was detected by the UV imager. Limited by the paper length, one of them was showed in Figure 7.

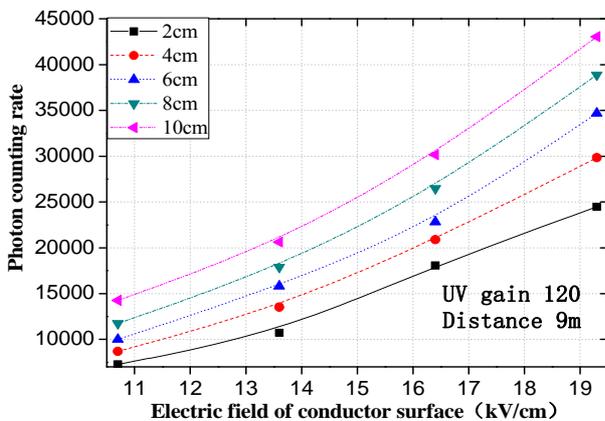
Figure 8. Influence of electric field.

With the applied voltage of 150kV, 190kV, 230kV, 270kV, the electric field was 10.7kV/cm, 13.6kV/cm, 16.4kV/cm, 19.3kV/cm, respectively, one part of result of experiment was show in Figure 8.

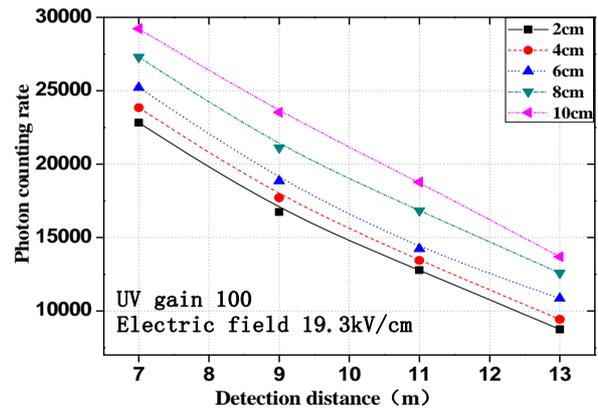
Figure 9. Influence of detection distance.

With the different detection distance of 7 m, 9 m, 11 m, 13 m, the results were partly showed in Figure 9.

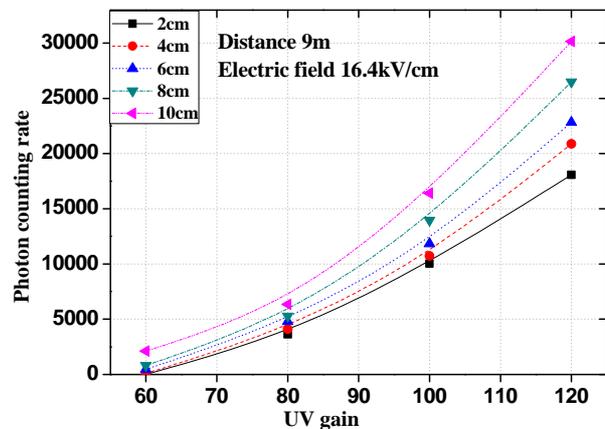
Figure 10. Influence of UV gain.

With the different UV gain was set in the experiment, the results were partly showed in Figure 10. However, the UV gain character is most related to the signal processing module of the UV imager designer, so it may different from other UV imager.

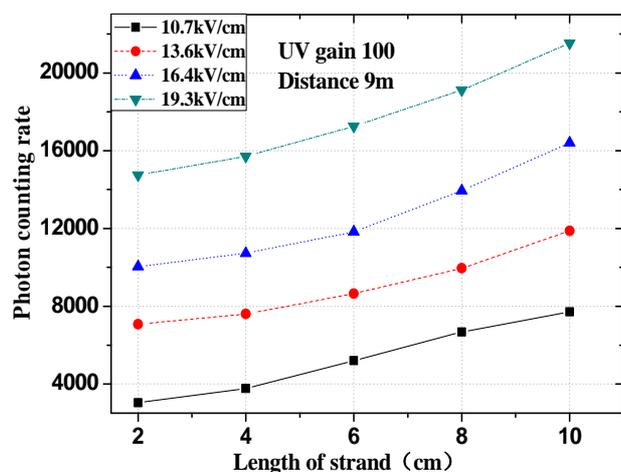
Figure 11. Influence of strand length.

With the different length of strand applied on the conductor, the results were partly showed in Figure 11.
